## Reordering Update 9<sup>th</sup> February

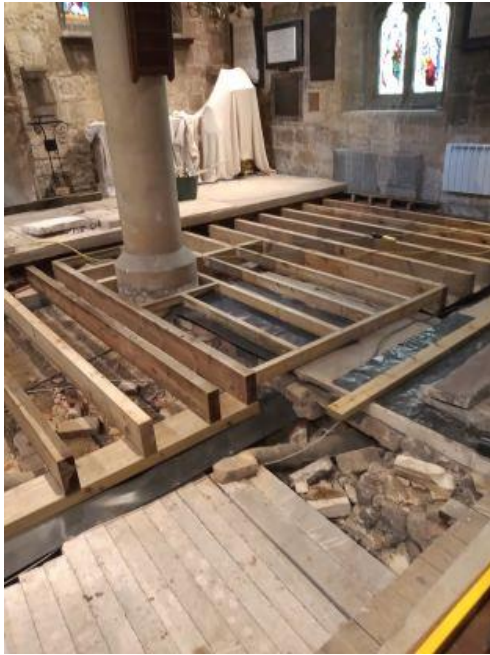
The old joists have gone and the new ones are in position. A few of the old joists were rotting, were not as substantial as the replacements, and were supported by dry brick pillars.

The ply flooring has been partially laid in this picture, and to the left the top of the heating tunnel, covered by concrete posts, is visible.

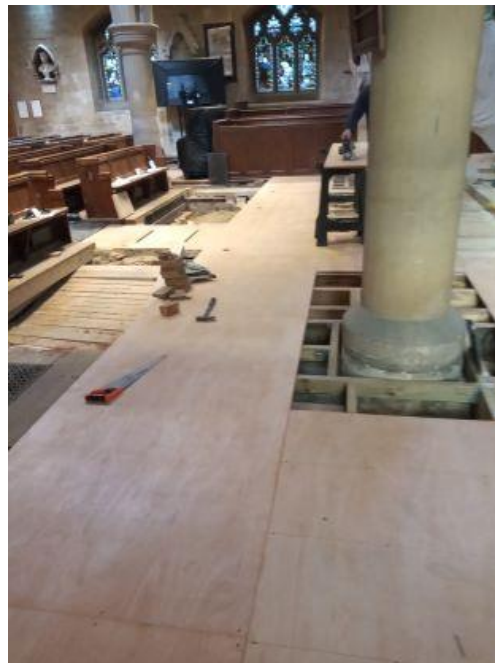
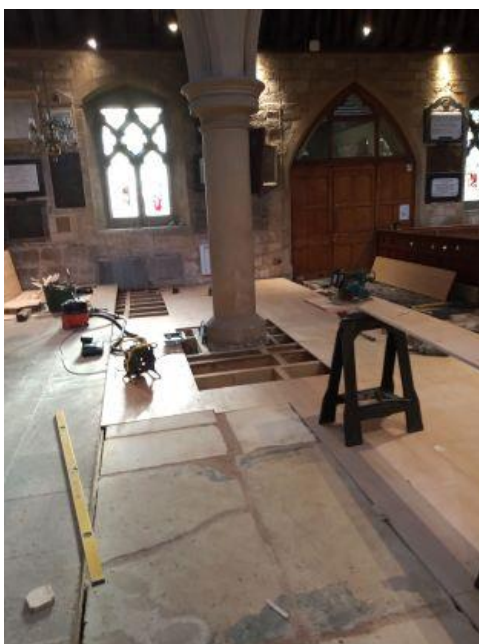
Looking towards the vestry, with the wooden flooring partly laid. At each end there is an inspection hatch for future builders, architects, wardens (!) to look underneath the floor.

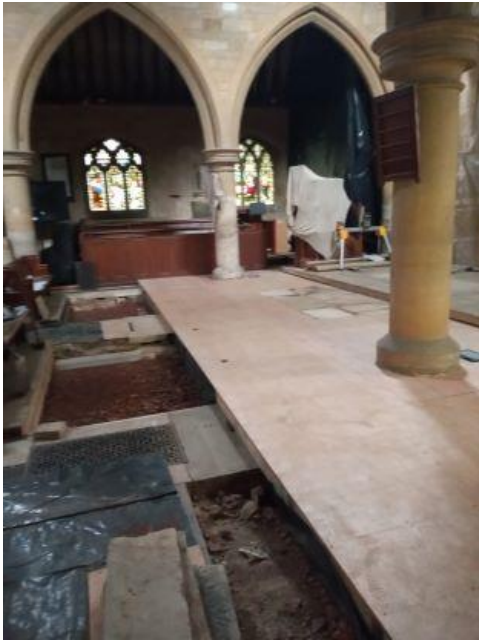
The wooden flooring is virtually complete and awaiting the oak edging. The stone flooring to the left will be a level stone surface from the vestry door to the choir stalls. The cracked monument in the floor by the vestry door will be repaired and relayed.

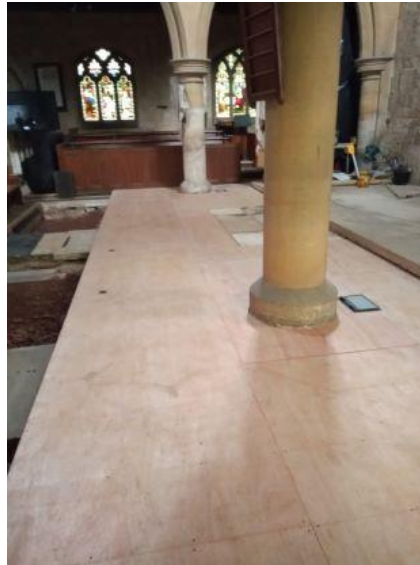
When complete, with the oak edging, the wooden floor will be carpeted in red, hopefully to reflect the red in the stained glass windows.

Along the front edge, just visible, are square sockets to support the altar rails. By the vestry wall there are matching sockets for safe storage of the rails when not in use.
